ASPASA TOOLBOX TALKS HEALTH & SAFETY DELIVERY OF CONCRETE

TBT014

18 August 2021

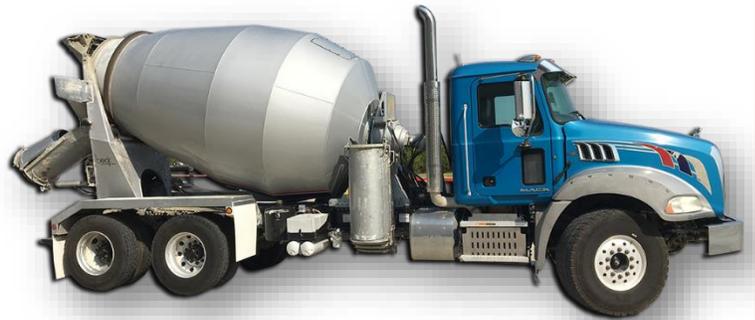
Incident 1:

A mixer driver filled a concrete skip on a customer's site. A construction site operative attached a metal lifting chain to the concrete skip and then directed a plant operative to lift it with a loadfall.

When the skip was at a height of approx.2m, the lifting chain snapped, and the skip fell. It landed at the rear passenger's side of the lorry. Fortunately, the driver stepped away from the lifting zone. This had the potential to be very serious. The driver noted that after the incident the site personnel then lifted the skip with a worn webbed sling.

- 1) There was no lift plan in place – the correct lifting accessory (chain or sling) to lift the concrete skip was not planned in advance.
- 2) Construction site personnel did not use a lifting chain that could lift this skip safely – they may not have known the weight of the filled skip and so used a lifting chain that was not strong enough or they may not have known or understood the rating of the chain.
- 3) The lifting chain may already have been damaged.

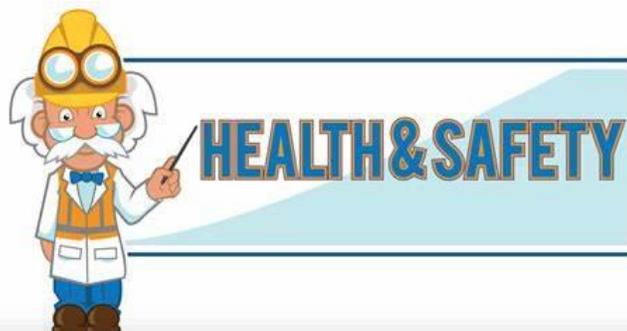
Incident Findings – Why did this happen?

- Drivers must stop to assess every delivery site – if it is not safe to deliver, contact your line manager or use your **STOP WORK** card.
- Head to toe high visibility clothing, metatarsal safety boots, hard hats, safety glasses and gloves must be worn when outside the cab.
- Always look for overhead hazards whilst on sites – this includes objects falling from scaffolding, items being lifted by plant or cranes and overhead lines. Hard hats must be worn at all times.

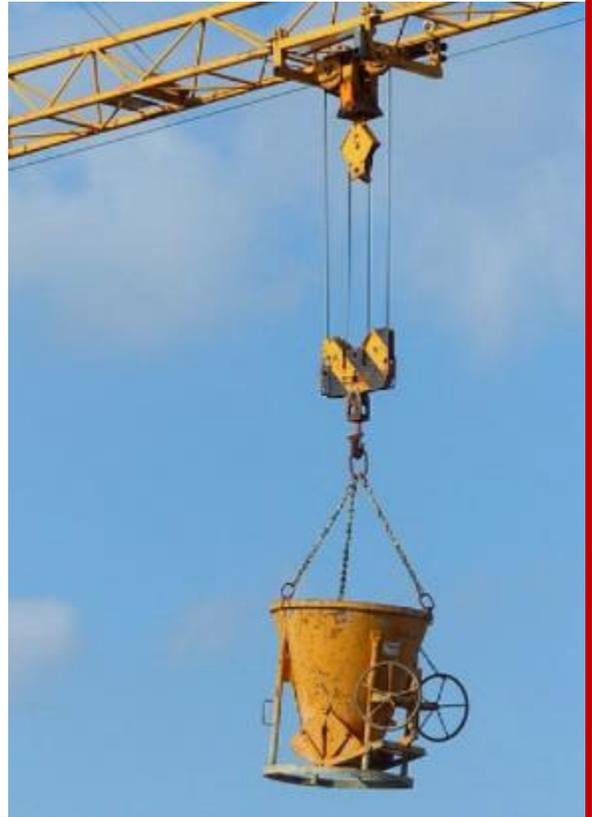
Incident 2:

A concrete mixer driver was delivering to a customer's construction site. The mixer driver climbed the ladder on the lorry, then the site banksman directed the tower crane operator to lower the skip and then directed the skip hose into the hopper of the lorry drum. When the driver pulled the rope on the skip to release the concrete into the drum the skip hose blocked, sending concrete back up the pipe covering the driver's hard hat and upper body. The driver was not wearing safety glasses but fortunately was not seriously injured.

- 1) The customer's procedure for waste concrete was not followed by their site team i.e., waste concrete must be poured into forklift bucket for removal to the site tip.
- 2) The driver felt under pressure to return the unused concrete to the mixer drum.
- 3) There was no foreman on site to ensure waste procedures were followed.

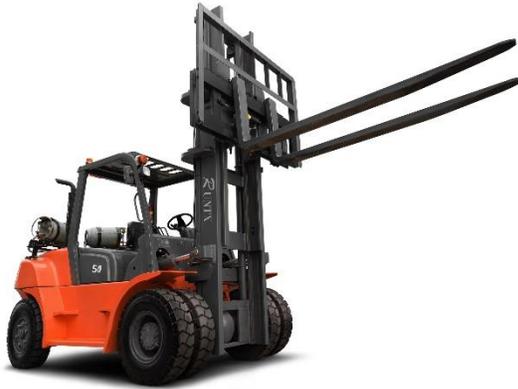
Incident Findings – Why did this happen?

- Drivers and all site personnel must move to a safe area well outside the lifting zone when concrete skips and any other items are being lifted overhead.
- Drivers must not handle concrete skips. It is the responsibility of the customer to safely dispose of any unused material in concrete skips – it must not be returned to the drum of the mixer lorry.
